River Nene: Castor Back Channel

Version 1 (24.11.12)

Location:	Downstream of Water Newton Weir (c3km west of Peterborough)
Upstream Grid Ref:	TL103977
Length:	c 1100m
Completion Date:	Spring 2012
Cost:	£40,000
Partners:	The scheme was implemented by the Environment Agency with the co-operation and agreement of the Nene Park Trust (landowner) and the support of Peterborough and District Angling Association (PDAA) and the Bedfordshire, Cambridgeshire and Northamptonshire Wildlife Trust.

Summary of Techniques: Bank reprofiling; bank revetment using ash faggots and spiling; installation of ash faggot flow deflectors; securing in-stream woody debris; gravel introduction to augment an existing run; excavation of new fish refuges; installation of new cattle drinkers and a "dog-dip"; riverside fencing; willow pollarding; riverside tree planting to create shade; and wildflower seeding. The bridge beams were also repainted with vandal resistant paint to address an existing graffiti issue.

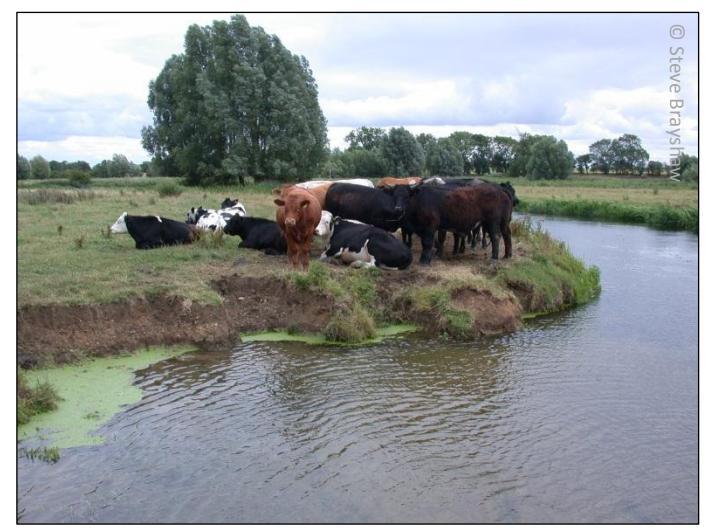
Fig 1. Severe erosion by cattle at drinking locations

The river has traditionally been used to provide drinking water for livestock, but there was no specific provision of drinkers to limit the widespread impact of severe poaching. To reduce the impact cattle drinkers were installed at the (severely eroded) favoured drinking places in each of the fields. Excess earth, excavated during the construction of the drinkers, was used as supplementary fill behind the bank toe protection (see above). The cattle drinkers on the right bank comprised post and rail enclosures with a base of rammed limestone. However, because of the excessively hard bed adjacent to the left bank drinker the specification was modified to use angle-iron uprights instead of wooden posts on the front fencing to prevent stock from entering the river.

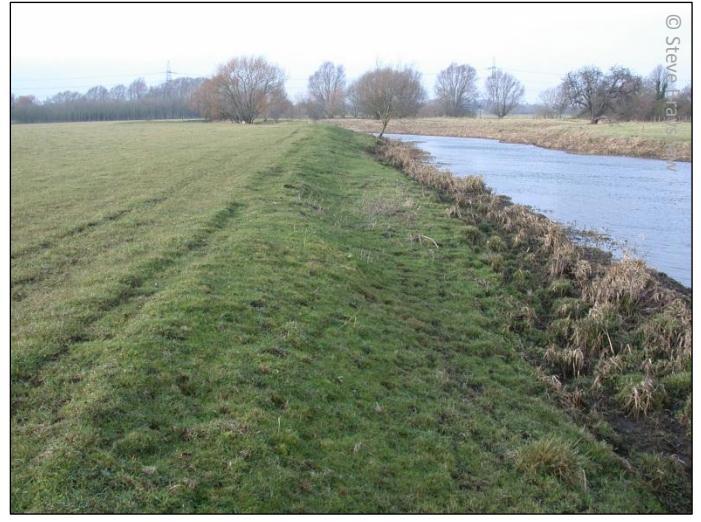
Fig 2. Wide channel with uniform flows during the winter, few shade trees on south bank, cattle poached margins

During the summer months extensive beds of in-stream vegetation (in particular grey club-rush *Schoenoplectus tabernaemontani*) created useful flow variation. However, in the winter, when the vegetation died back, flows were more uniform. Consequently, to create year round variations in flow, ash faggot and hurdle deflectors were installed. As well as increasing the flow velocity, the deflectors will encourage siltation at the margins of the channel and this will allow the extent of the marginal vegetation to increase, whilst maintaining an open, energetic central channel. All, apart from one, of the deflectors point upstream to reduce the potential for bank erosion. The downstream pointing deflector, located to protect and encourage the extension on an existing *Schoenoplectus* bed, deflects the flow towards a section of the bank that has been protected by spiling revetment. Note - initially a much larger number of flow deflectors were planned, however the number was reduced because the channel was too deep for them to be installed.

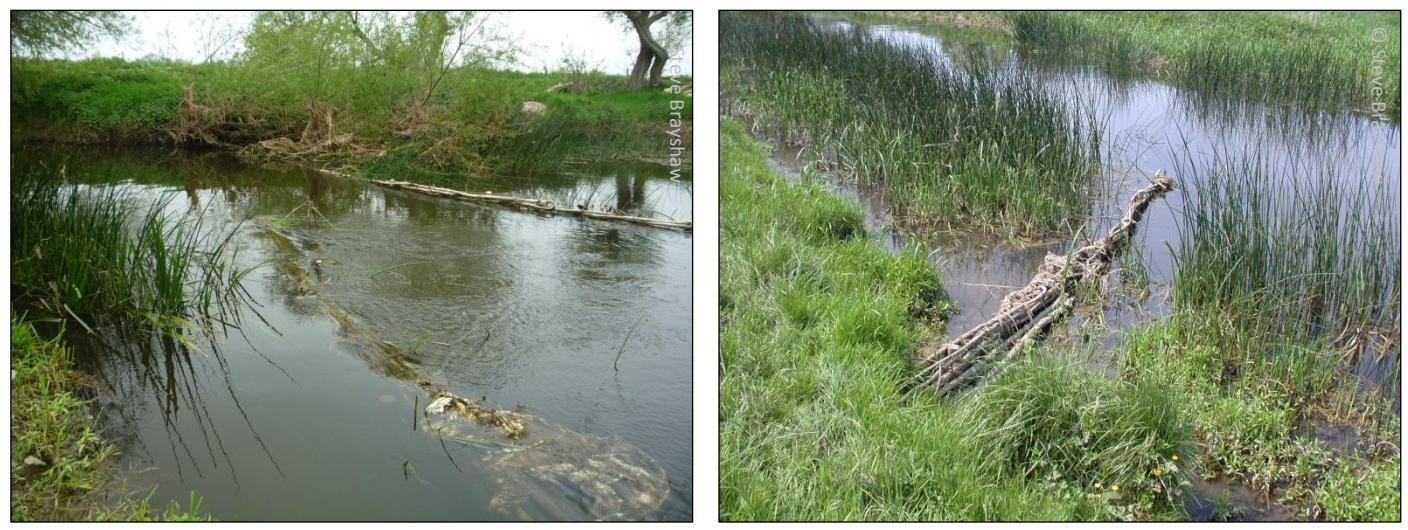
Figs 3 & 4. Faggot deflectors used to pinch the channel and to consolidate existing and encourage future siltation

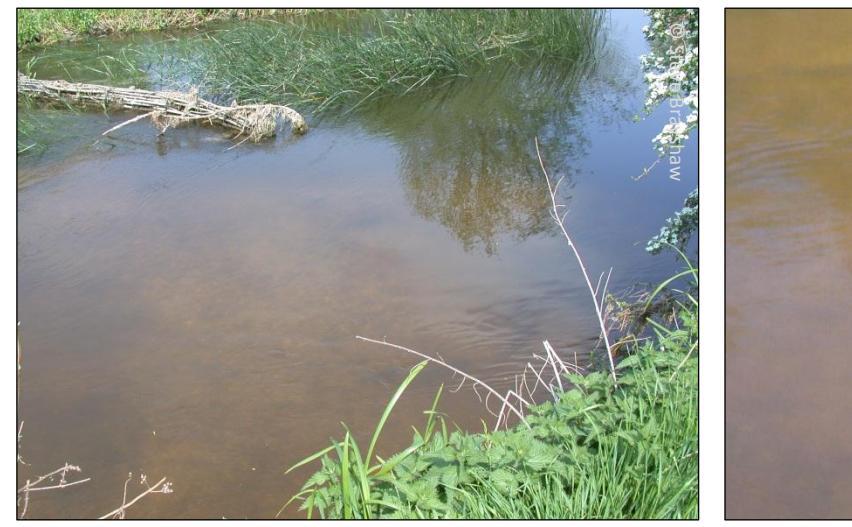
Fig 5. Gravel placed to augment an existing run

sharp bends in the middle of the reach. The run was augmented by the addition of 40 tonnes of 20mm diameter gravel to improve opportunities for fish spawning and habitat for invertebrates. In addition, an ash faggot flow deflector was installed to concentrate the year round flow over/through the gravel to ensure that siltation was minimized. The gravels, which remained in place following the high spring flows, immediately attracted large chub and barbel.

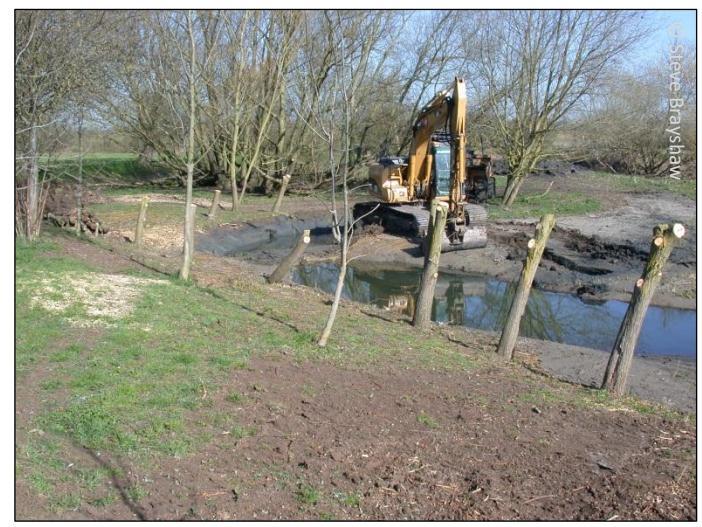
Two pools were excavated on the existing lower lying areas within the channel. These pools are designed to act as fish refuges during medium to high flows. The downstream pool is within an area of wet woodland and a line of new pollard willows on the southern side will provide additional shade.

Fig 7. Lower refuge pool under construction

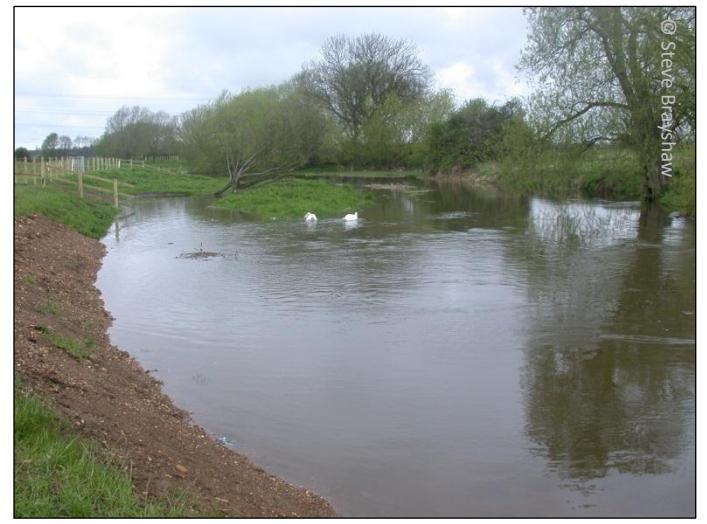
Fig 8. Upper refuge pool during high flows in April 2012

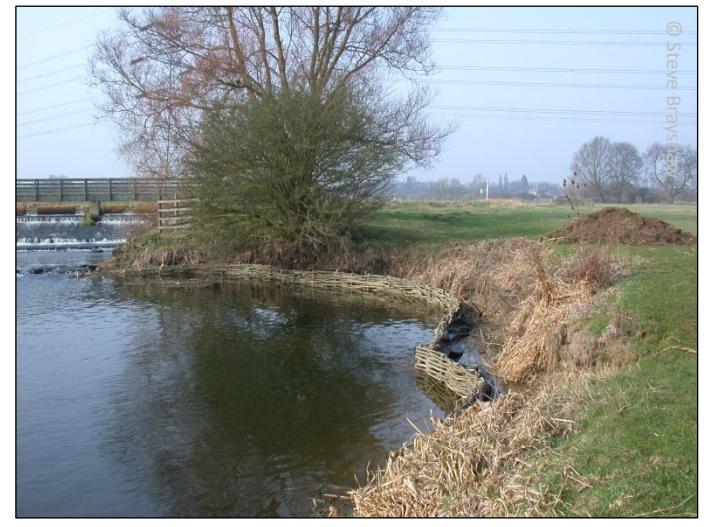
Fig 9. Ash spiling used to protect bank toe

The majority of the right bank and the upstream and downstream ends of the left bank suffered from very severe erosion, mainly from cattle, but also from people and dogs. The majority of the severely eroded banks were reprofiled behind ash spiling, backed with a geo-textile membrane, with faggots being used to consolidate the bank

toe where the bed was extremely hard. The bare earth on the reprofiled was seeded with a simple meadow grass seed mix augmented with the addition of some wild flower seed derived from the species list from Castor Flood Meadows SSSI just downstream of the back channel.

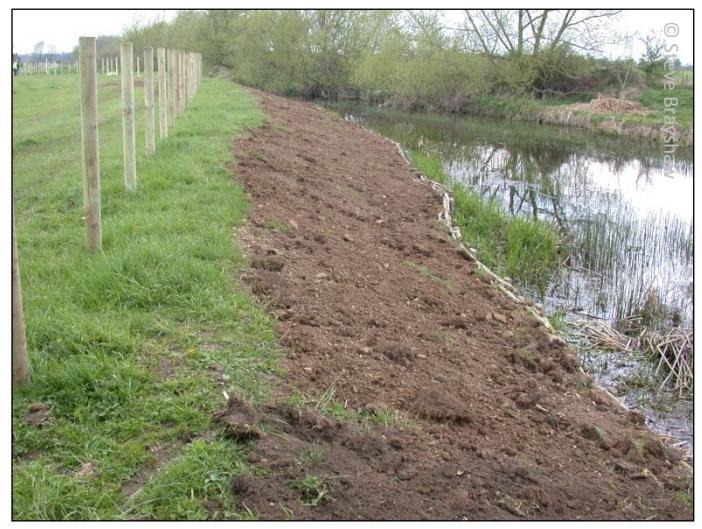
Fig 10. Eroded bank reprofiled behind spiling

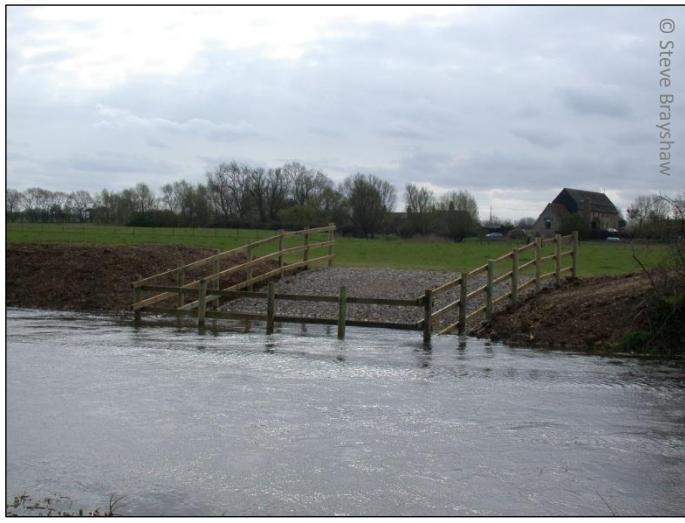
Figs 11. New "standard" cattle drinker

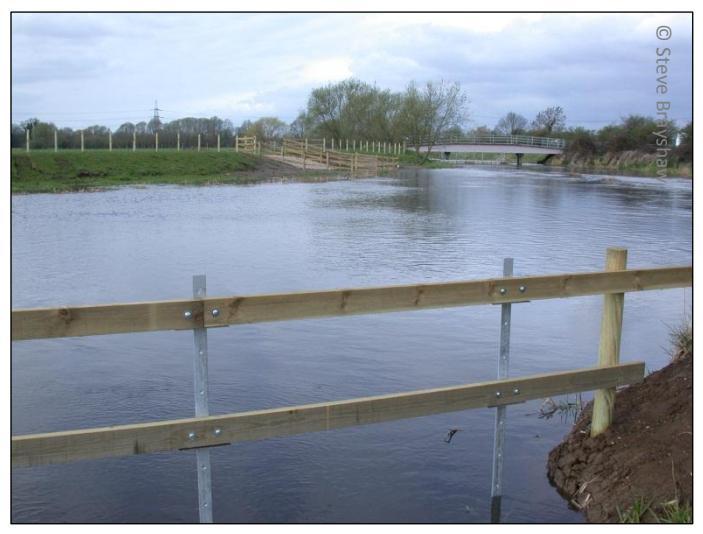
Fig 12. Cattle drinker front fencing showing angle iron uprights used to penetrate the hard river bed.

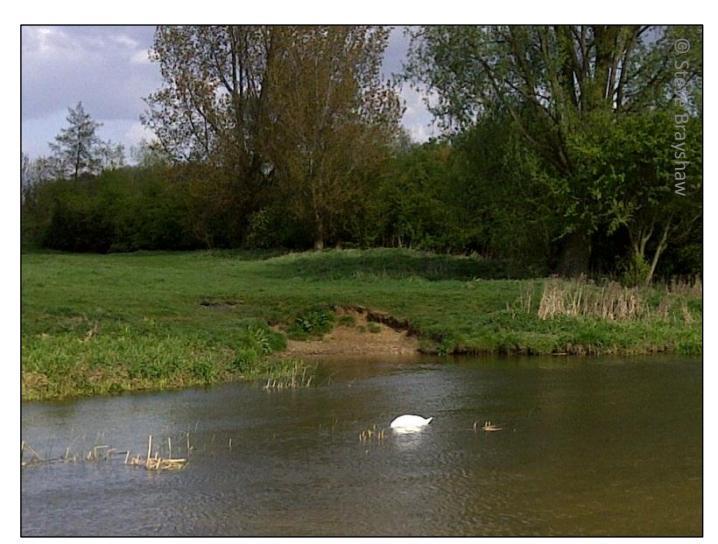
In addition to the cattle-eroded areas, there was a section of eroded bank caused by recreational access. Rather than prevent access to the water here the bank was reprofiled and the bank and river bed were dressed with gravel to allow the use by people and dogs to continue but to limit the impact of soil erosion.

Fig 13. Before: the eroded recreational access

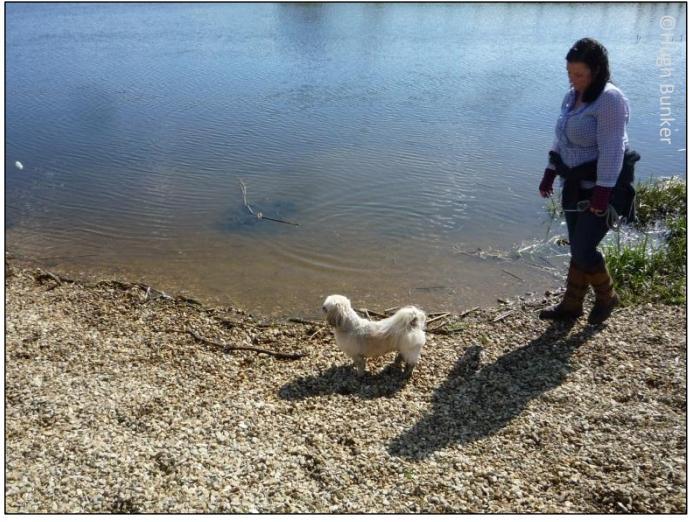
Fig 14. After: the repaired "dog- dip"

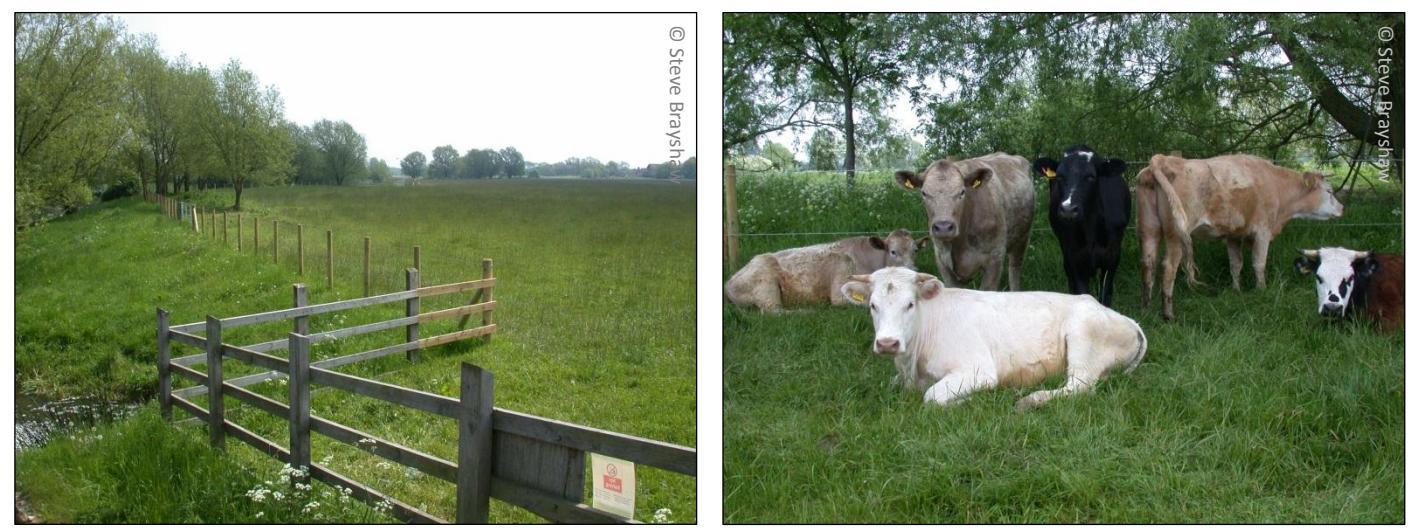
At the start of the scheme all the redundant fencing around the wet woodland and the damp berm downstream of the bridge was removed. On completion of the in-stream works new fencing (wooden posts and 2 lines of barbed wire) was erected to protect the repaired banks; broad areas of damp riparian grassland that occur within the channel; the wet woodland area; the refuge pools; and a small group of trees at the confluence of the back channel and the main river channel. Simple pipe-stiles were provided along the fence-lines, which were set back from the bank crest, to allow access for anglers. Metal field gates were erected to allow access for stock to the in-channel grassland to enable light, controlled grazing to take place when conditions are suitable thus preventing the development of rank grassland and scrub.

Figs 15 & 16. New Stock fencing protecting in-channel grassland and wet woodland

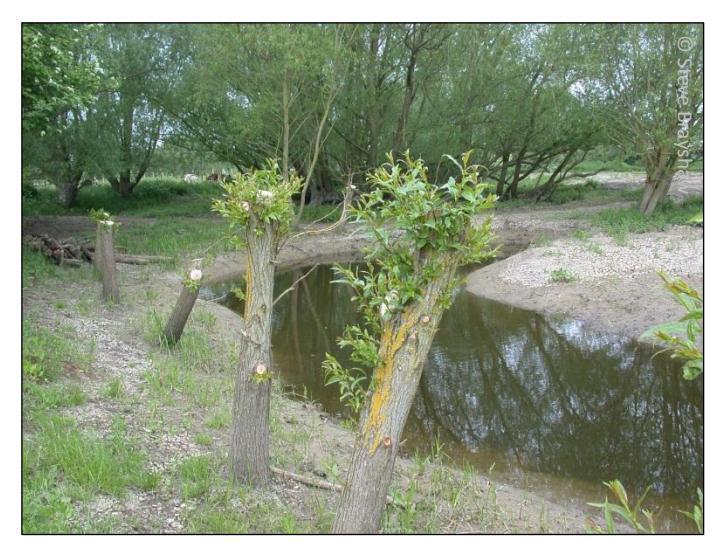
A limited amount of tree work was undertaken. Several young willow trees were pollarded on the edge of the wet woodland to allow access for machinery to excavate the refuge pool. These will regenerate rapidly to provide shade, which will improve the quality of the refuge. Two live willow limbs were also dropped into the water and secured to narrow the channel and create a bankside fish refuge.

Fig 17. New pollard willows

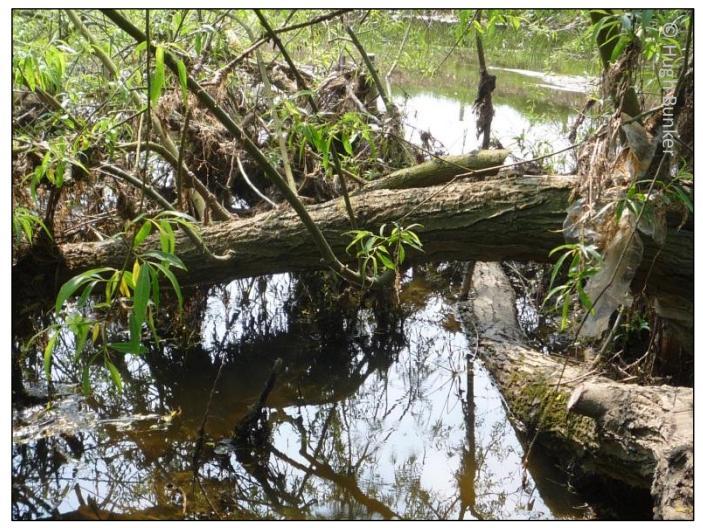
Fig 18. Live willow limbs secured in channel

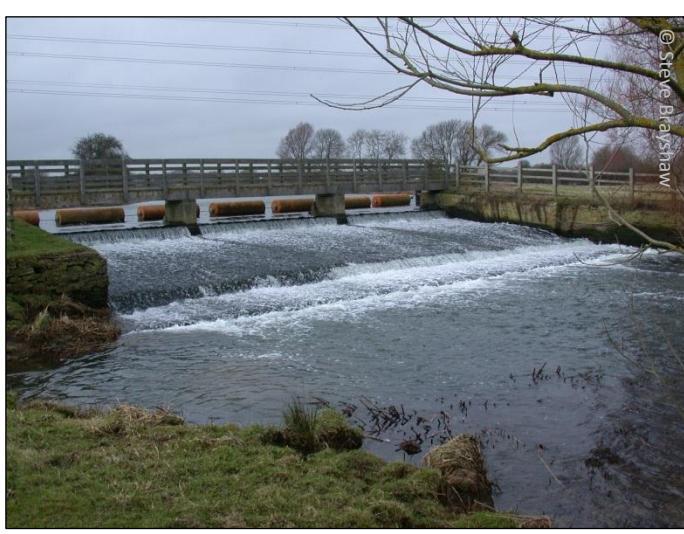
Fig 19. Water Newton Weir is currently a barrier to fish and eel passage

As the works were completed in the spring it was too late to undertake the proposed alder planting on the southern bank to provide additional shade. Tree cribs were constructed and Nene Park Trust will complete the planting in the winter of 2012/13. In addition a fish and eel pass is required at Water Newton Weir.

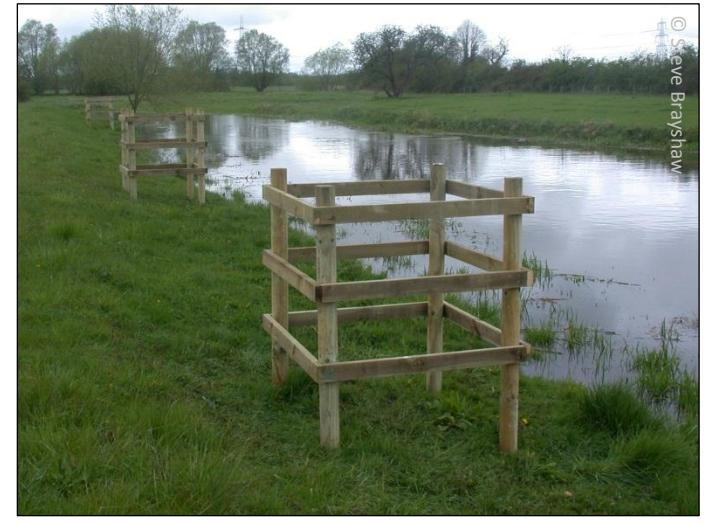
Fig 20. Cribs to protect alder planting in scheduled for winter 2012/13

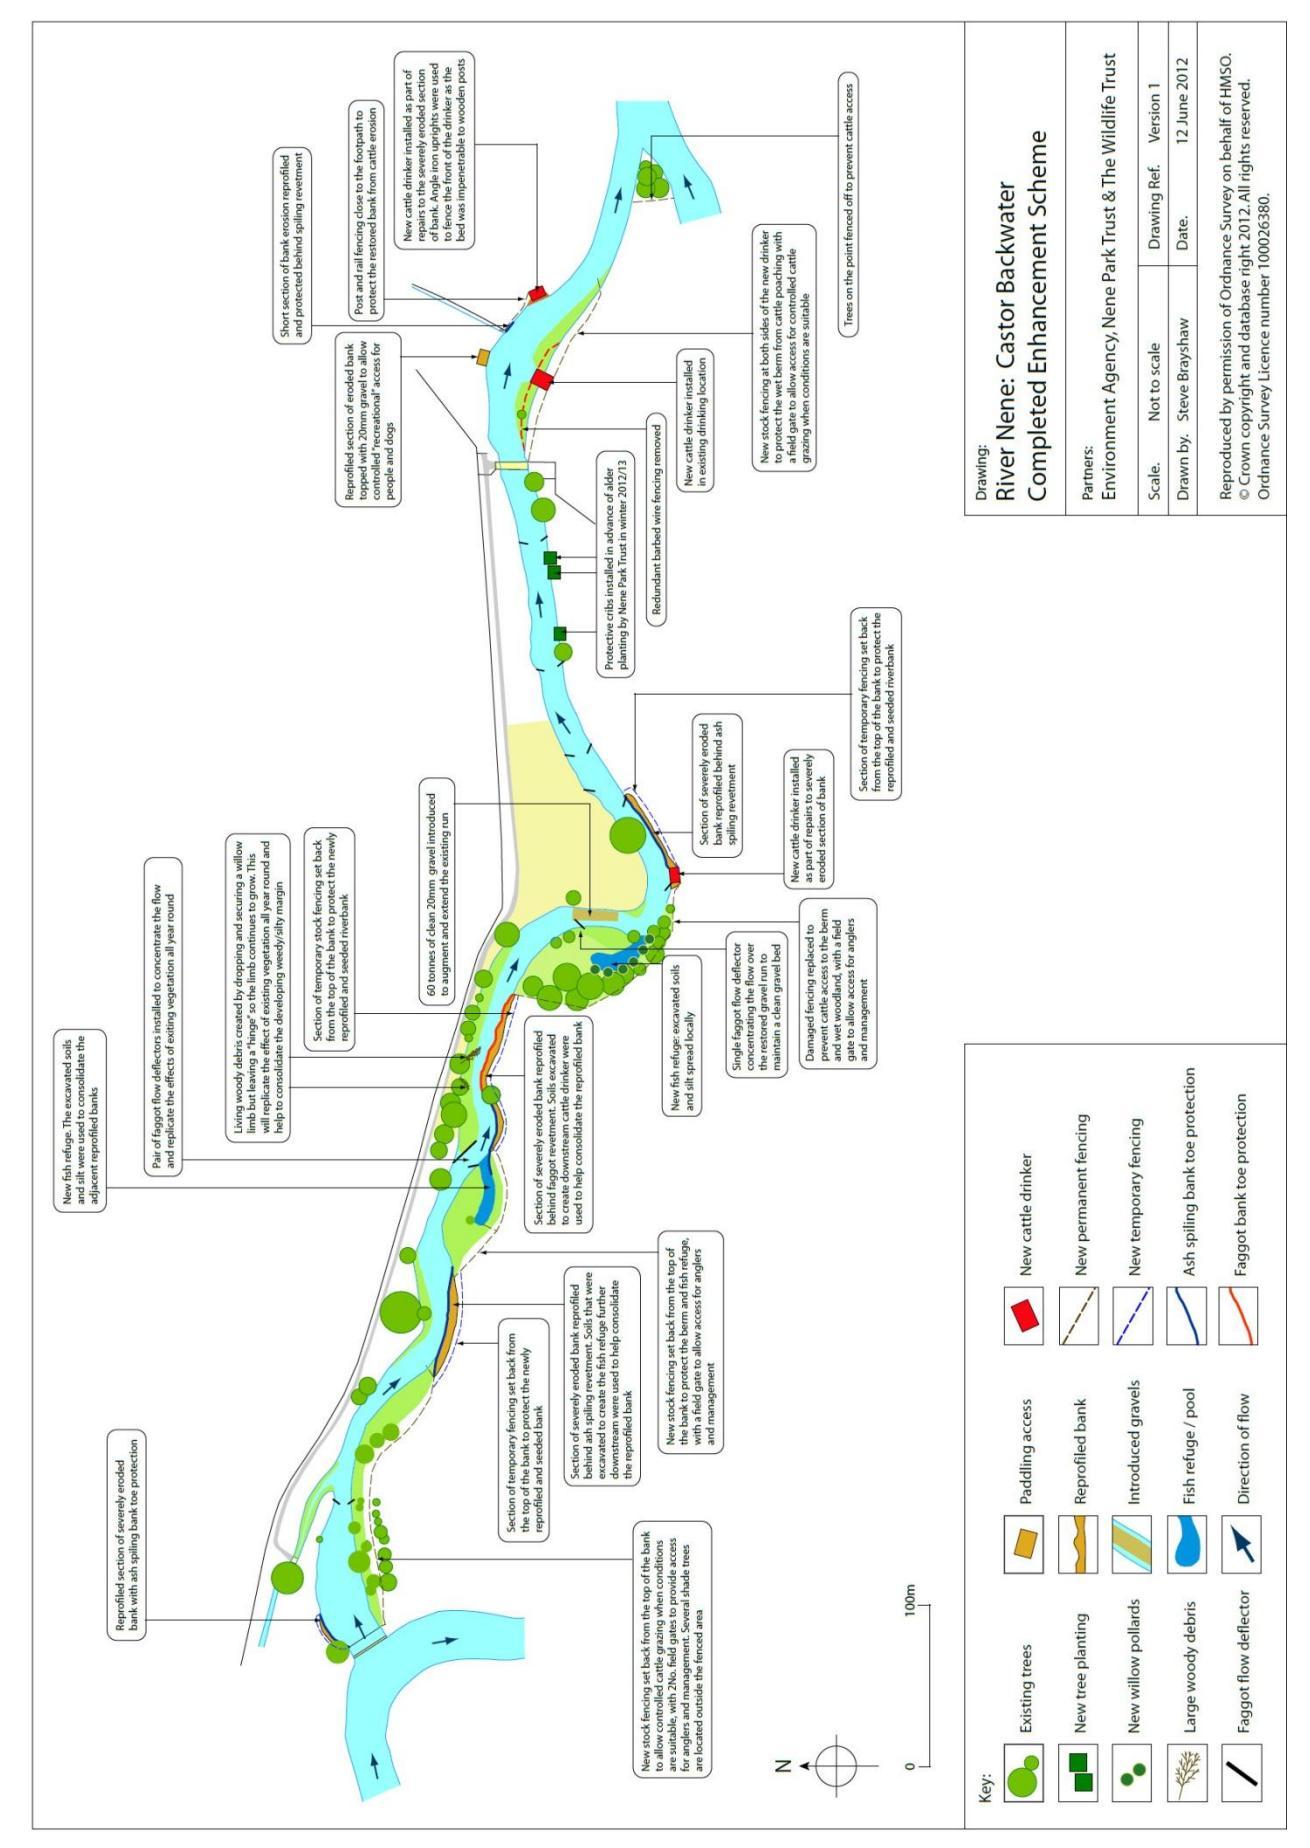
ANNEX 1: The Completed Enhancement Scheme

The main elements of the project were implemented in March 2012. The drawing in Annex 1 shows the locations of all the elements of the completed scheme. The techniques used are described below. It should be noted that the works started during a period of particularly low flows and concluded following a period of heavy spring rainfall which caused the river to overtop its banks.
